Status of Crocker Cyclotron Refurbishment

Eric Prebys, Director, Crocker Nuclear Laboratory

May 9, 2018

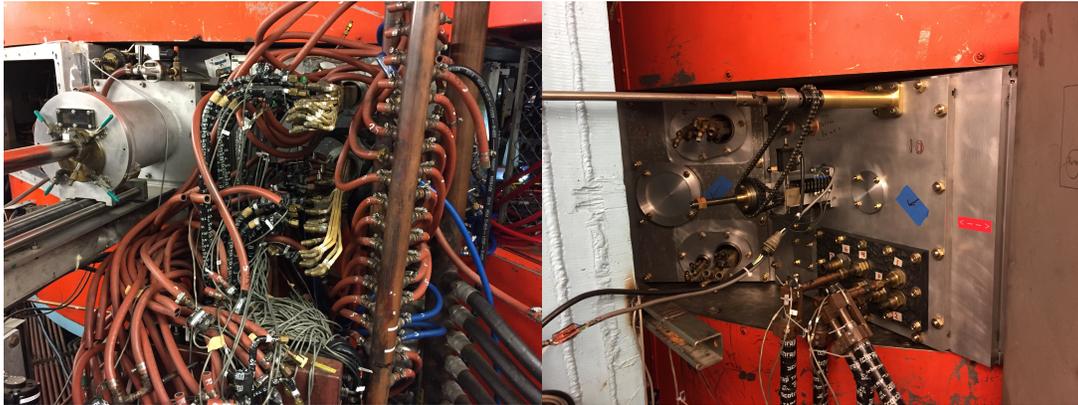
Figure 2: Complexity of feed-through plates

Figure 2 shows some examples of the complexity of the interfaces.

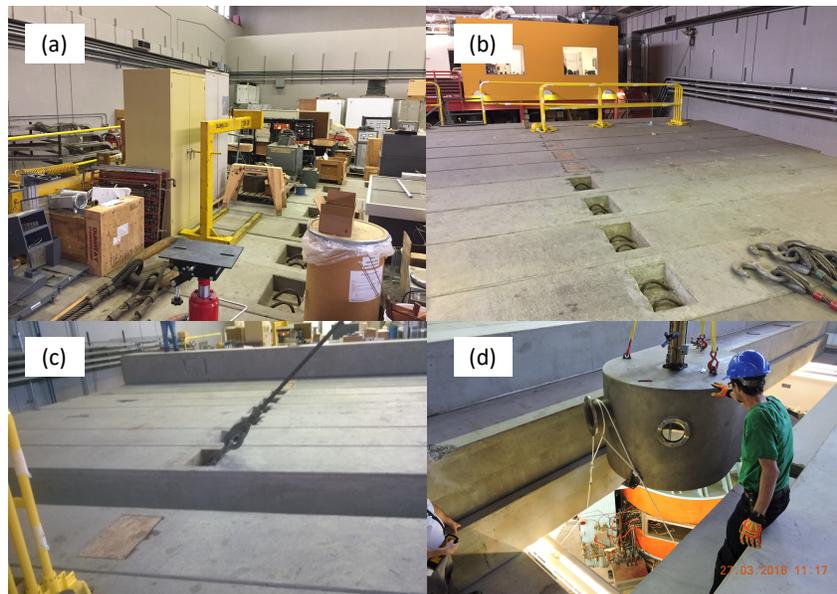
Figure 3: Roof operations, showing before (a) and after (b) clearing, the beginning of block removal (c) and the removal of the vacuum pump elbows.

The situation was complicated by the fact that both the vacuum elbow on the West side and the resonator flange on the East side required crane access. This necessitated the removal of shielding blocks on top of the vault. Unfortunately, the top of the vault had been used for storage for some time, so clearing it required several days at the beginning of the operation, as illustrated in Figure 3.
